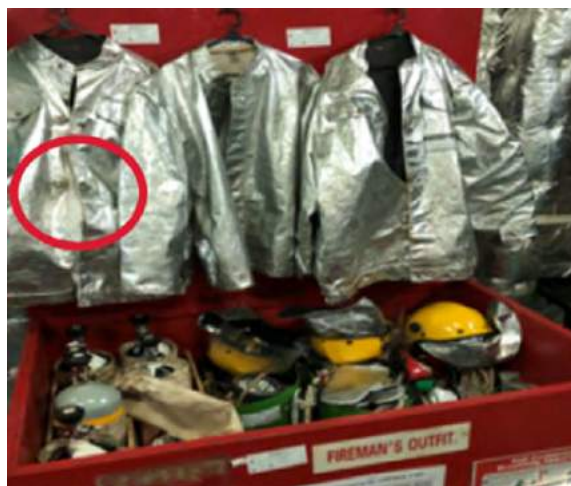
Many suits on board are designed in accordance with the EN 531 standard. However, this standard is designed for industrial workers exposed to heat and is not intended for firefighting. Moreover, some suits labeled under EN 531 feature unprotected metal zippers, buttons or clasps, which can conduct heat and cause burns.

Figure 1: Suits with unprotected metal buttons do not provide the necessary thermal insulation.

Although not stated in the EU-MED, the correct firefighting suit standard for firefighting inside enclosed spaces (e.g., accommodation, engine room, etc.) is EN469 level 2.

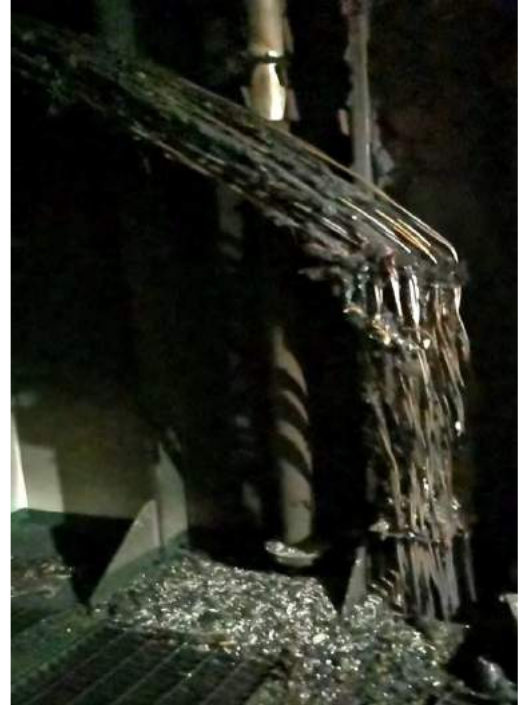
- Inadequate guard / barrier:
  - Pipe insulation had not been covered with a fire blanket or any other protection despite the fact that the welding of the support angle bar in the floor panels / gratings was in close vicinity

- Poor housekeeping / disorder - Shipyard personnel carrying out the hot work job did not keep the surrounding area in order or well protected against fire risks. The hydraulic pipes in the vicinity had flammable insulation material capable of burning rapidly once ignited

*Burnt fittings inside the pumproom*

- Discuss the incident in your next safety meeting including shipyard related:
  - Requirement of keeping HoD and office representatives informed on any deviations of the agreed work plan
  - Hot work practices
  - Liability during dry docking / afloat repairs in shipyard, according to Owners and Managers agreement
- Conduct onboard training on the usage of the stop work authority. Encourage and ensure active use of the stop work authority and unsafe act / condition reporting
- When planning drydock / shipyard repairs, BSM representatives must discuss with Owners:
  - Structure of drydocking
  - Arrangements / responsibilities related to shipyard safety
  - BSM policy and procedures
  - Liability during dry docking / afloat repairs in shipyard facilities according to Owners and Managers agreement

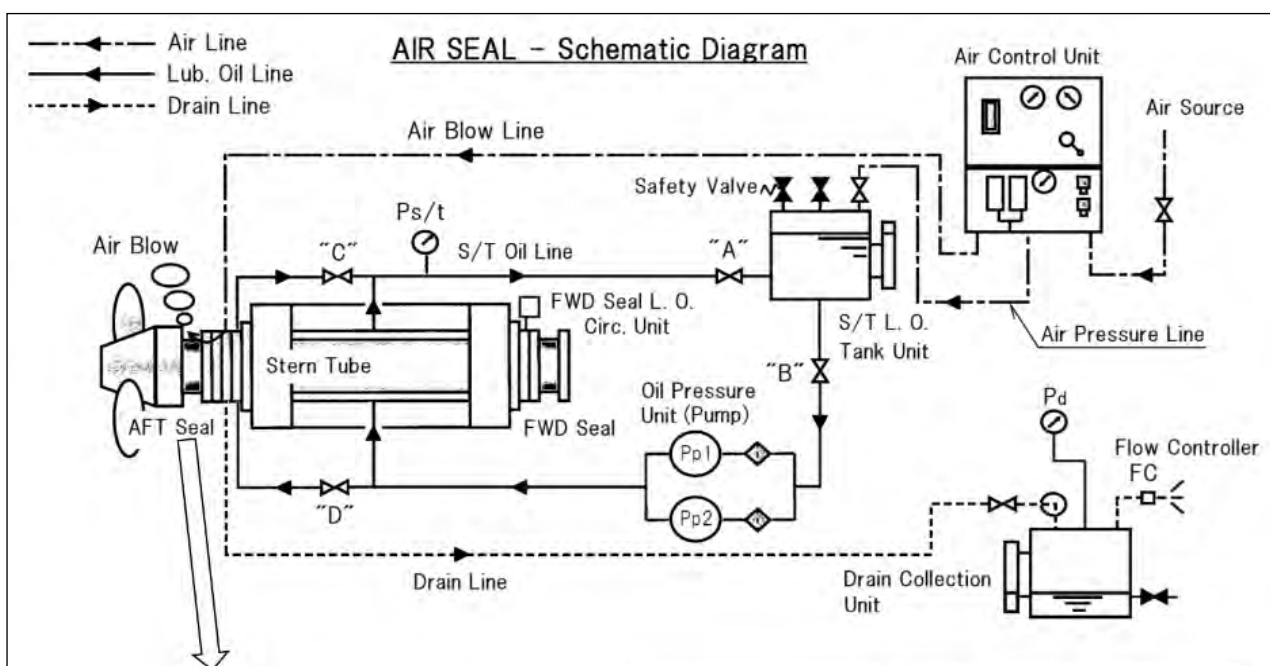
STSS Makers: Kemel

An 'air seal' in the STSS keeps sea water out by blowing air into sea through an air chamber provided in the space between the no. 2 and 3 aft seal rings. Segregation of sea water and stern tube oil by air chamber minimizes the risk of sea water contamination.

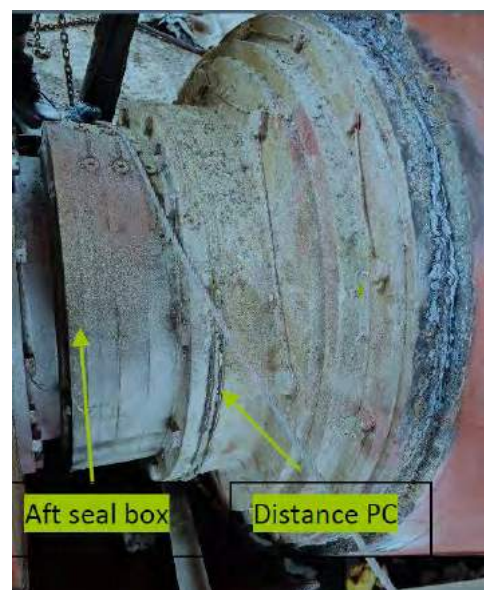
- Defective equipment - The distance piece gasket adjacent to the stern tube seal box was found damaged
- Inadequate adjustment / assembly - During the recent DD of the ship, the maker's service engineer did not adequately tighten the nut / bolts of the distance piece adjacent to the stern tube seal box

- During stern tube repairs / seal renewals, pay attention and reiterate to the makers engineers the importance of proper tightening
- Discuss the incident and familiarize your engineers with the operation and maintenance of the stern tube oil system fitted on board
